Surface tyre imprints caused by a motorcycle collision rather than by being run over

Medicine, Science and the Law
0(0) 1–5
© The Author(s) 2018
Article reuse guidelines:
sagepub.com/journals-permissions
DOI: 10.1177/0025802418810102
journals.sagepub.com/home/msl

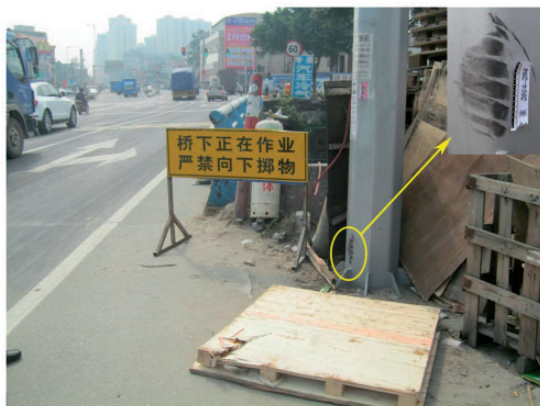
Figure 1. Tyre marks of the front wheel of the motorcycle on the pillar (the next day).

The day after the accident, the scene and the vehicles suspected to be involved were examined. The tractor's outline was 6115 mm × 2495 mm × 3560 mm, its curb weight was 7280 kg and its total weight was 18,000 kg. The trailer's outline was 16385 mm × 2480 mm × 1670 mm, its curb weight was 7500 kg and its total weight was 37,980 kg. The asphalt road had three main lanes, with two auxiliary roads on the right. A cement fence and a sign pillar were at the junction of the left auxiliary road and the right lane. A tyre mark (2.5–3.0 cm in width) was found on the sign pillar (15–30 cm off the ground; Figure 1). Strip-like scratches were found on the ground from the base of the sign pillar to behind the guide arrow painted on the right lane (Figure 2). A bloodstain (proved to be from the victim by DNA test) was found on the

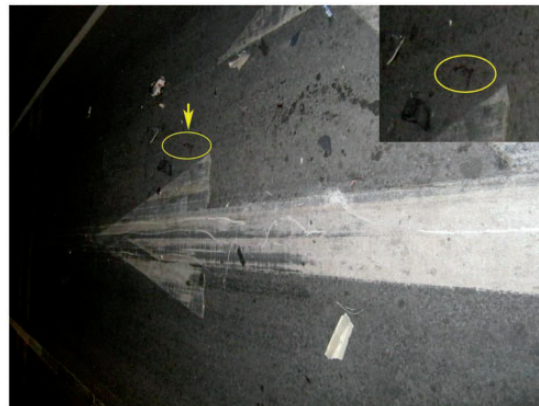
Figure 3. A bloodstain from the victim found on the ground that indicated his final location (intraday).

ground on the left side of the right rear wheel of the tractor (Figure 3).

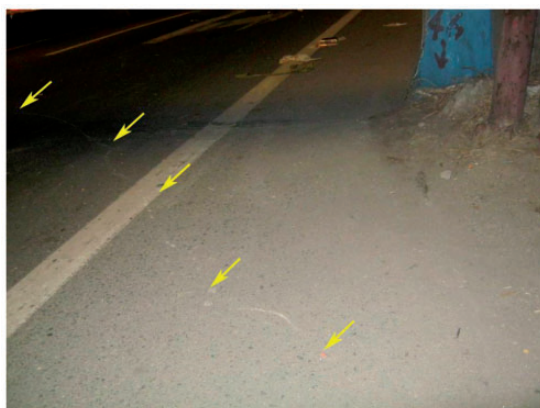
Figure 2. Scratches formed by friction between the motorcycle and the ground showed the trajectory of motion of the motorcycle after the collision with the pillar (intraday).

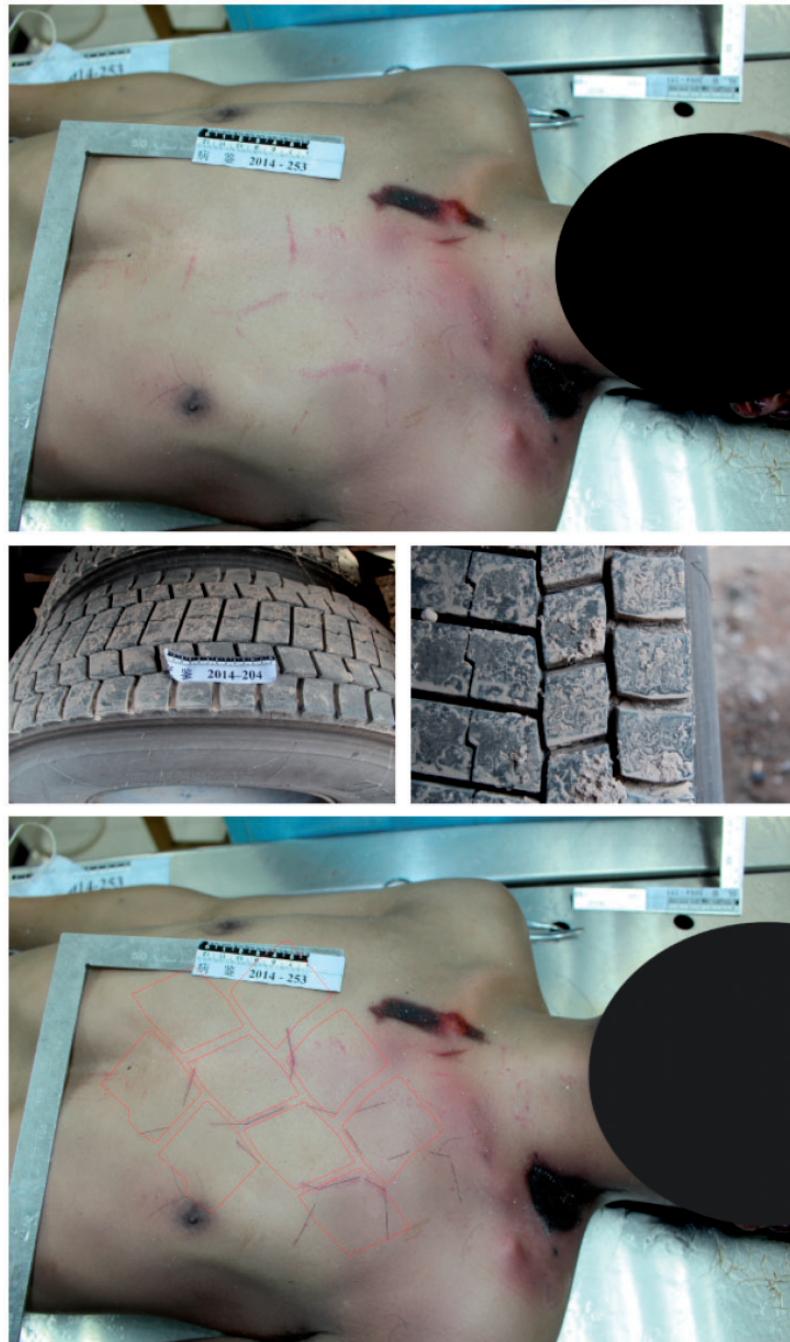
Figure 4. The skin of the left chest showed wavy red lines. The width of these lines and the distance between them corresponded to the grooves of the tyre on the trailer's right rear lateral wheel.

We compared the patterned injury on the left chest with the tyre pattern,⁴ finding that they were consistent with concave pattern of the right rear wheels (Figure 4)

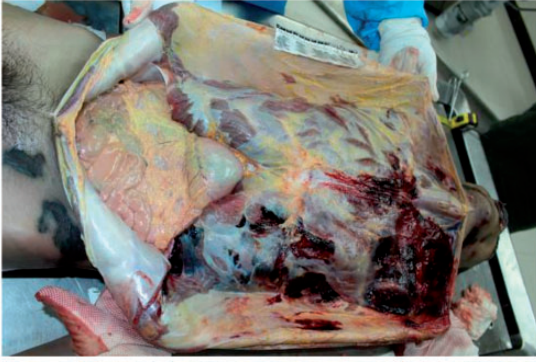
Figure 5. Injuries to the thorax and abdomen.

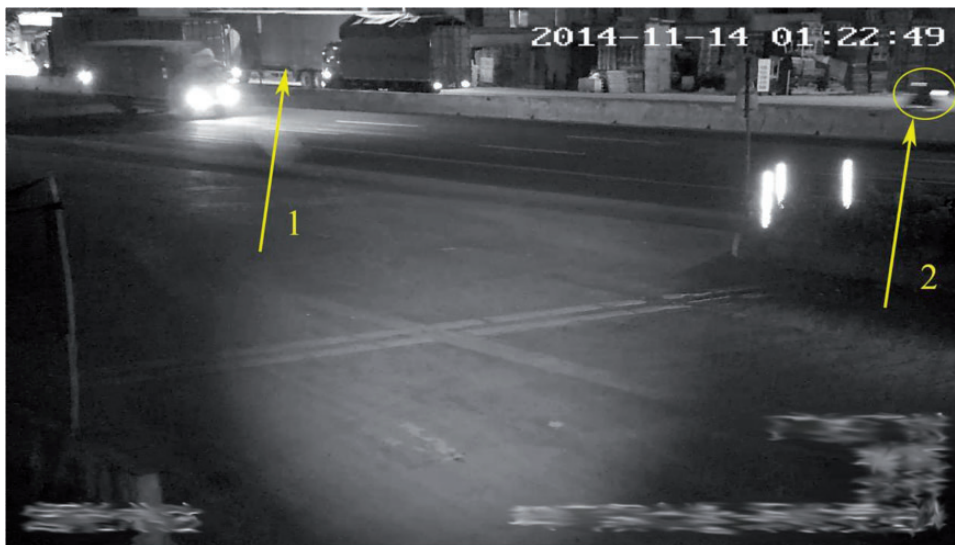
Figure 6. A screenshot from the surveillance video. 1. The tractor-trailer. 2. The victim on his motorcycle.

Based on traces (the bloodstain, scratches and other evidence) from the scene and information from the surveillance video (Figure 6), three-dimensional scanning of the main objects at the scene and the vehicles suspected to be involved was performed to reconstruct the accident by utilising a method for object location in images based on 2D/3D registration.⁵ The final positions of the tractor, trailer and pillar were

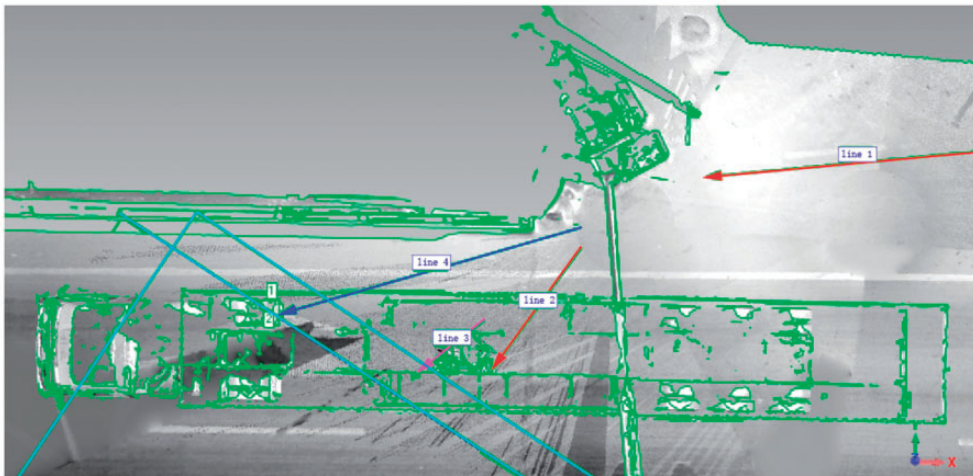
Figure 7. Scene reconstruction. Line 1: The motorcycle's track before its collision with the pillar. Line 2: The motorcycle's running track after collision with the pillar. Line 3: The final location of the motorcycle was estimated to be no further than this line. Line 4: The victim's track after his motorcycle's collision with the pillar. 1. The lateral edge of the tractor's right rear wheels. 2. The medial edge of the tractor's right rear wheels.

reconstructed as follows. The pillar was at the right rear of the right rear wheels of the tractor and the right front of the right wheels of the trailer. The motion trails of the victim and the motorcycle after the collision with the pillar are depicted in Figure 7. In addition, based on data from the surveillance video, we estimated that the victim's body collided with the tyre at a speed of 40–50 km/h.
