Case Report

Traffic accident or dumping? – Striking results of a traffic accident reconstruction

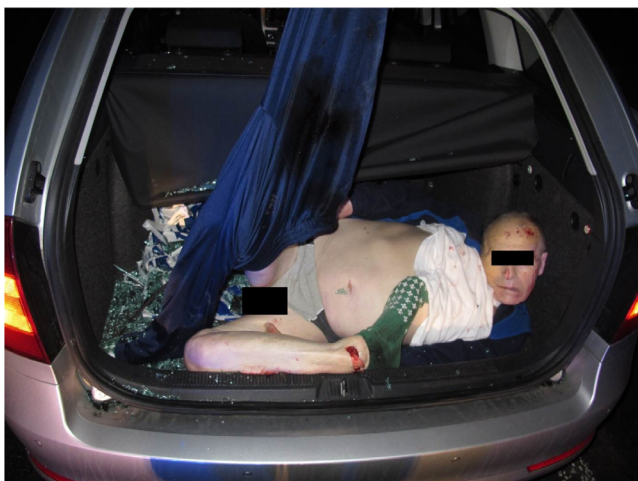
Fig. 1. Initial position of the deceased in the trunk of the car leading to suspicion of a coincidentally detected body dumping transport by the police.

looking upon a poly-traumatized and severely deformed male body (see Fig. 1).

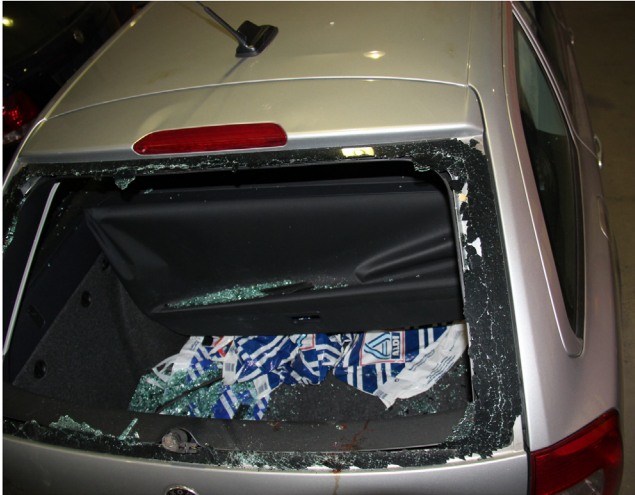
The right fender was completely destroyed, the right light-system pressed back into the engine-compartment and the windscreen was smashed at the right (see Fig. 2). There were several contact marks on the bonnet and the roof. The spoiler and the rear-window on the tailgate were destroyed (see Fig. 3).

Fig. 3. Back-view of the car: The rear-window on the tailgate is completely destroyed.

body rotations. His flight curve ends directly at the roof during massive deceleration of the car, where he touched the roof aloft the c-pillar (with arm or leg), smashed the rear-window from outside and landed into the trunk. An aggravation of injuries and lacerations during this landing is probable.
